RE: Public Nuisance: Combined Sewer Overflows into Public Spaces within New Haven

October 20, 2013

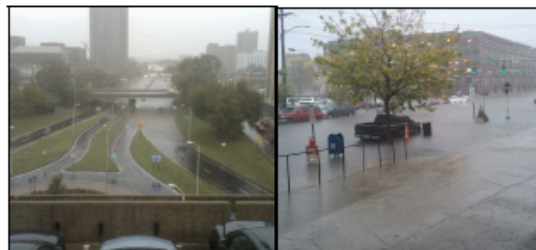
Fig. 1. Cover page of the Cardinal Engineering Associates Report.

The two images on the cover were taken on October 1, 2010.

The image on the left shows a flooded Rt. 34 Connector under the College St. bridge as seen from an upper level of the Air Rights Garage.

The image on the right depicts Union Avenue flooding.

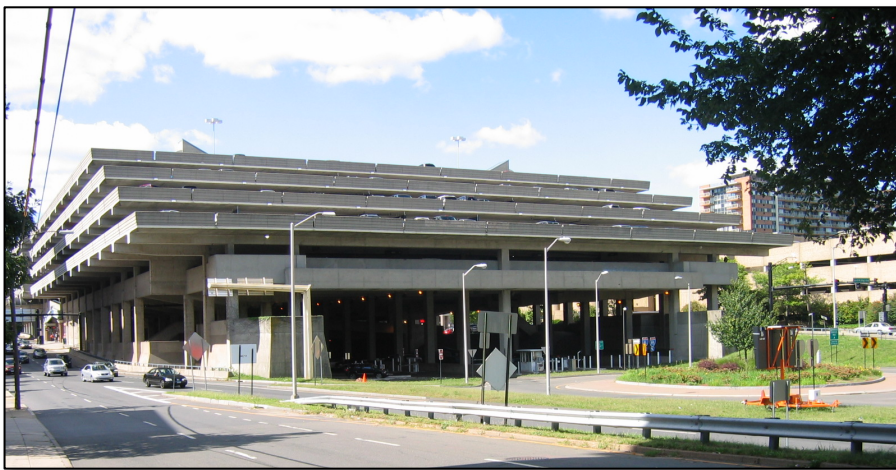
The UARG presently operates on land that was originally intended to be a portion of State Highway 34. Because the highway was designed to pass underneath the ‘Air Rights’ Garage, the UARG is situated in a deep cut of land that drops well below adjacent grades as one moves west from the eastern Entrance / Exit (Fig. 4).

Fig. 4. Air Rights Garage and the UARG Entrance / Exit at the eastern boundary of the ARG. Photo taken in August, 2012.

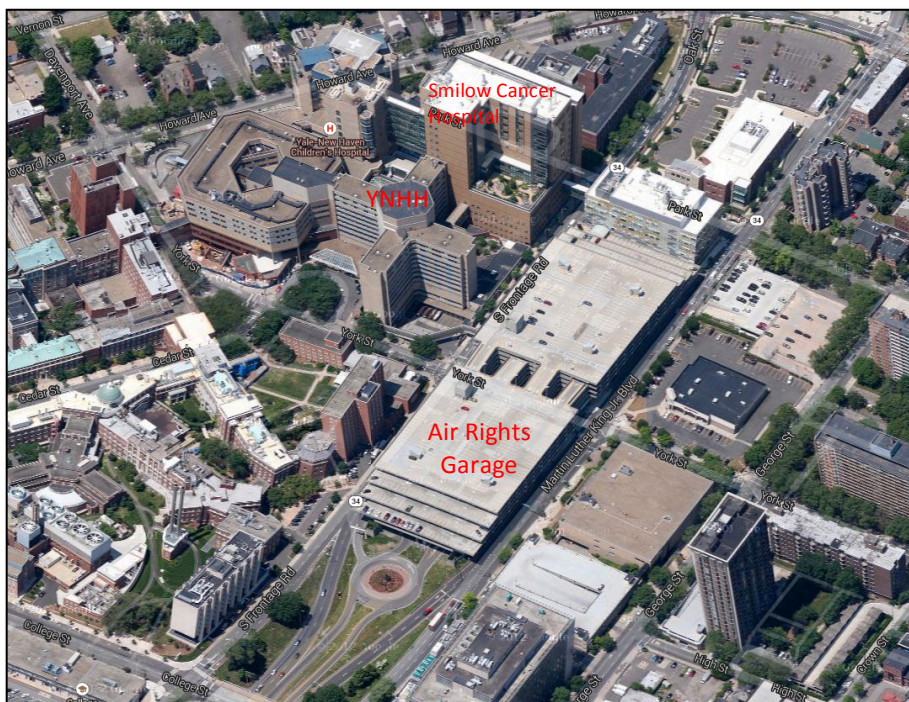
Fig. 5. Aerial view of the ARG and its relationship to YNHH and Smilow Cancer Hospital.

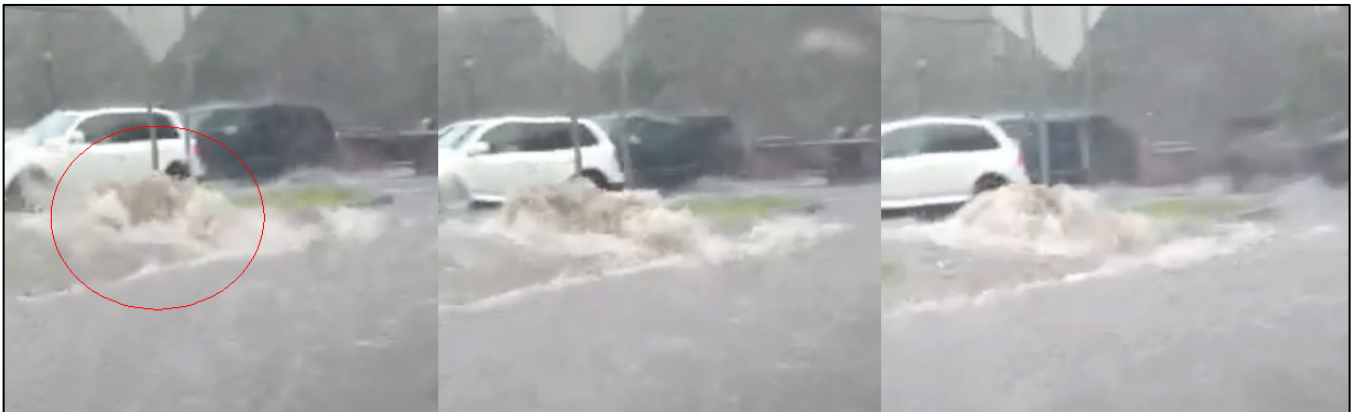
Then, on August 10, 2012, over 30 vehicles, most of which were owned by employees of CMHC, were damaged when a combination of untreated sewage and stormwater entered into the UARG (see Fig. 6 & 7a,b). All insurance claims were denied by the NHPA's insurance carrier, Travelers, because they found that the flood was not the result of any pre-existing defect within the UARG, and that the UARG drainage system was functioning normally. While the rainfall that afternoon was extreme, just short of meeting criteria for a **100-year storm**, the NHPA should have known about, with reasonable care, the flood risk in the UARG with *any sustained rainfall event* because it previously flooded during a **1-year storm**. Furthermore, several drainage analyses that described the inadequacy of the drainshed serving the hospital district were available to the CNH, and the NHPA, prior to the flooding of August 10, 2012.

Fig 6. Stills from a video clip taken on August 10, 2012 of backflow near the entrance ramp to the roundabout located just east of the UARG. The effluent at this location flows to the lower ground within the enclosed UARG space.

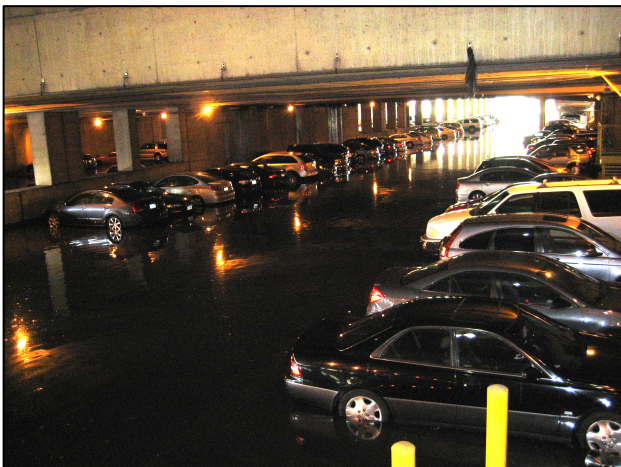
Fig. 7a. Interior of UARG with floodwater, looking east toward exit (August 10, 2012).

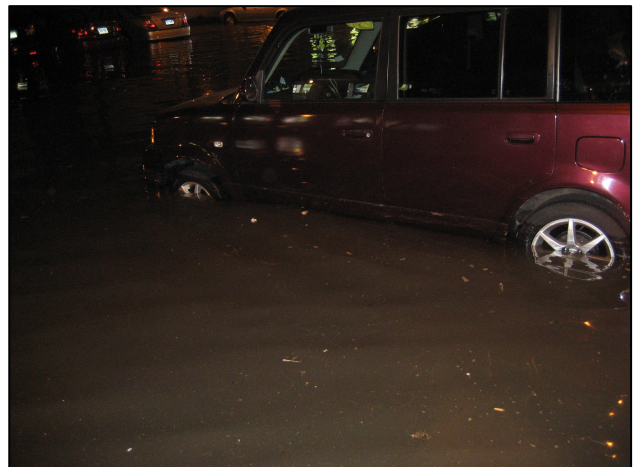
Fig 7b. Turbid floodwater in the UARG (August 10, 2012).

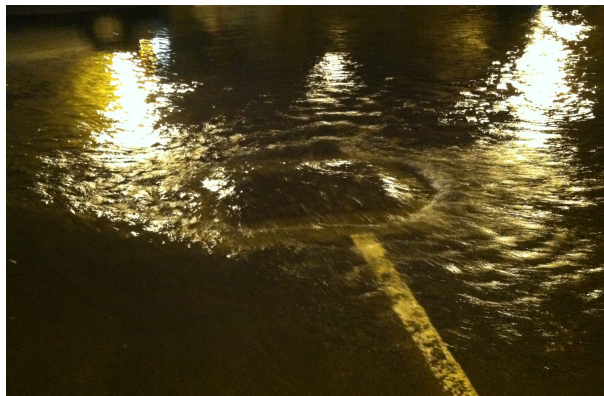
The UARG again flooded on September 28, 2012 during an intermediate intensity, afternoon rainstorm (Fig. 8a,b).

Fig. 8a. A still from a video showing backflow through a catch basin in the UARG on September 28, 2012.

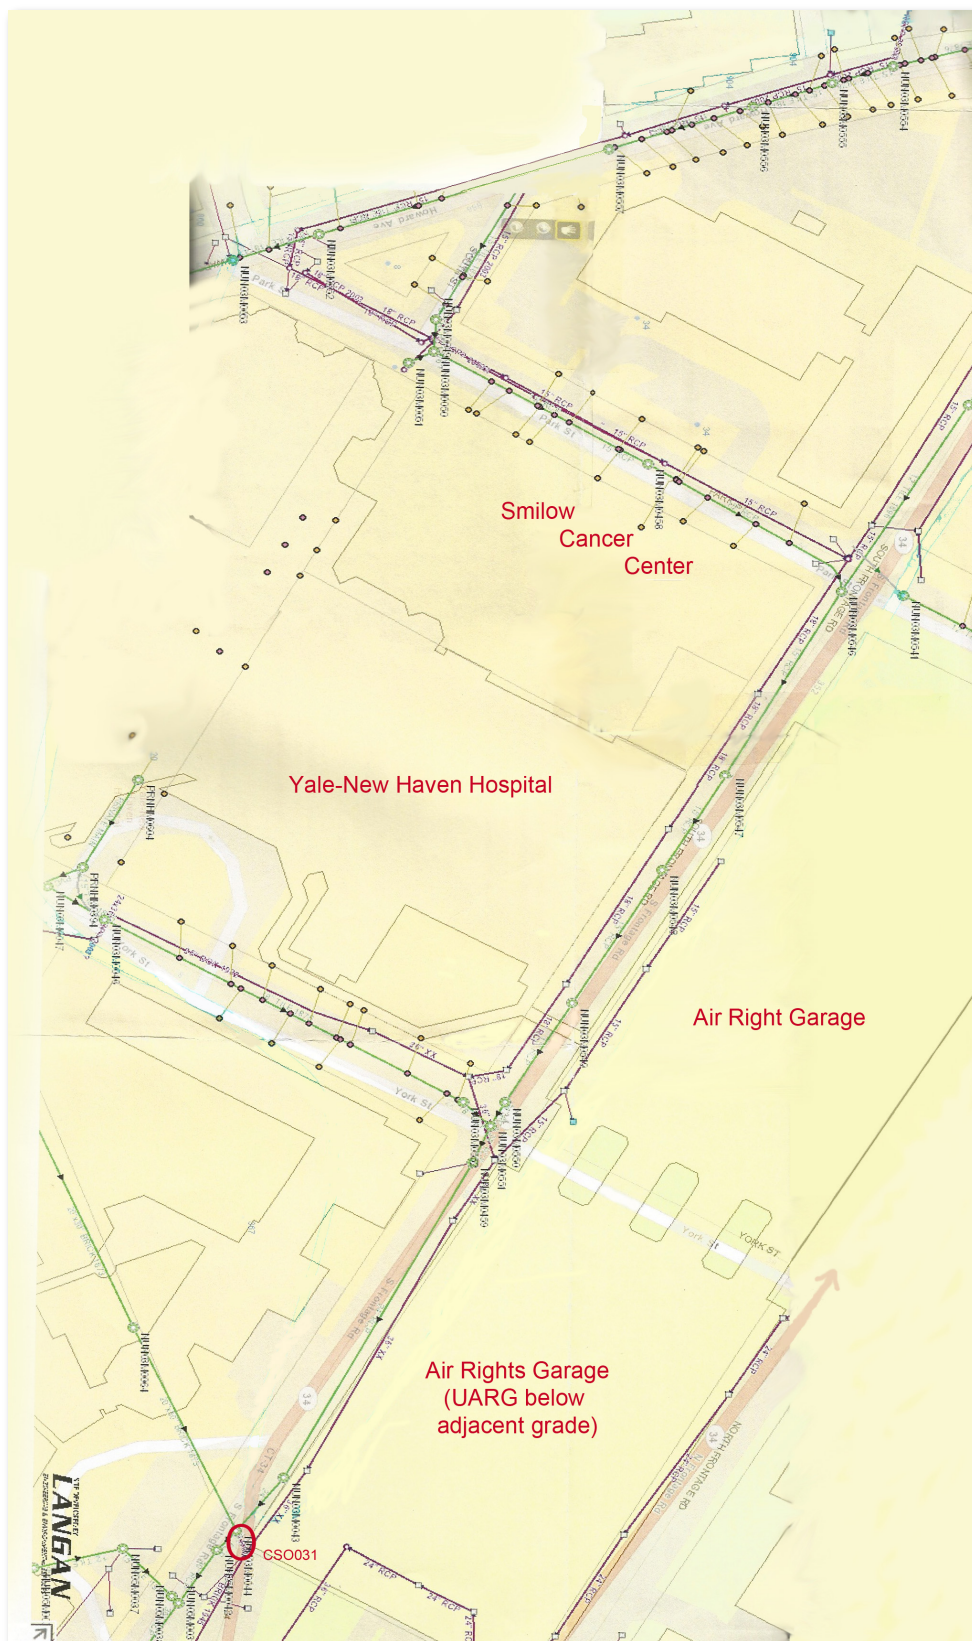
As seen in Fig. 10, the area adjacent to the UARG is served by an old combined sewer (green lines) that serves as the sanitary sewer for the area, including YNHH and SCH, and by a newer separate storm sewer system (purple lines). Please note the red circle in the lower left corner designating CSO 031. This piece of infrastructure is key to understanding why the area around the UARG remains at risk from flooding with untreated sanitary waste from the hospitals.

Fig. 10. Storm and Sanitary Sewer Map, ARG and YNHH area incl. CSO 031; merged and annotated printouts; originals provided by GNHWPCA in July 2013; Source: http://giswebviewer.gnhwpc.com/gnhwpc_CMOM/index.html (restricted access).

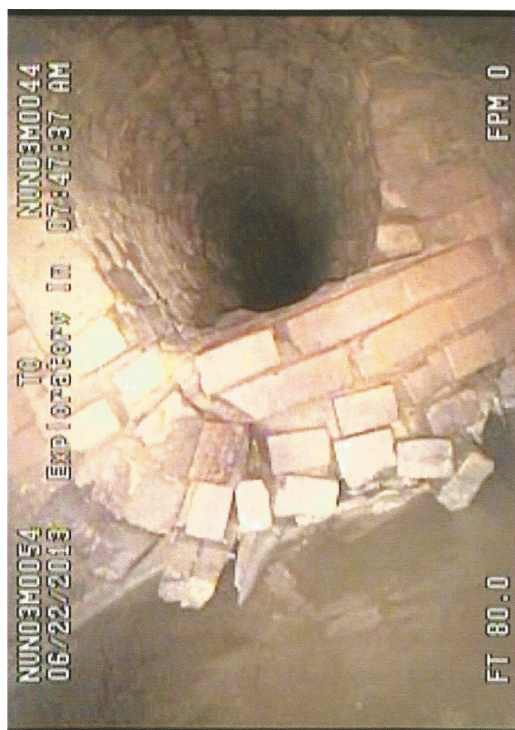
On August 6, 2013, the GNHWPCA provided me with images that demonstrated the cross connection at CSO 031 was in fact open, and not closed, as had been reported to DEEP (Fig. 15 & 16).

Fig. 16. CSO 031 - looking northeast toward the junction with the storm sewer system near the exit of the UARG.

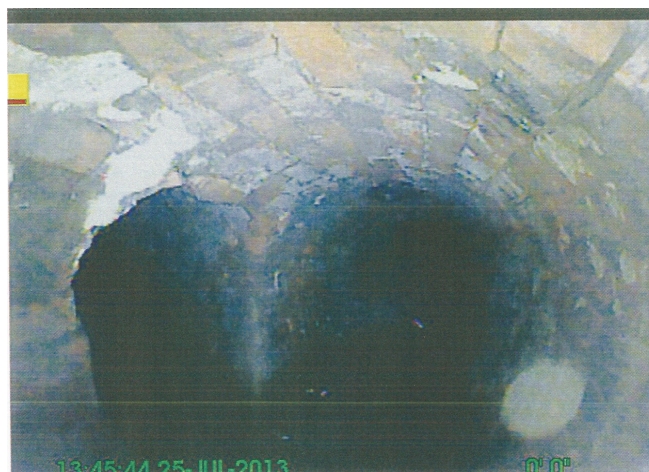
Fig. 15. CSO 031. The right sewer channel is looking straight into the separate storm sewer system that runs along the southern boundary of the ARG in Fig. 10 and in Fig. 14. The left sewer channel extends southwest to the other end of the CSO 031 that is shown in Fig. 16.
